1. AGENCY USE ONLY (Leave blank)		2. REPORT DATE January 1994	3. REPORT TYPE AND DATES COVERED Stage 3 report, 1994	
4. TITLE AND SUBTITLE Laser Induced Reaction for Prebond Surface Preparation of Aluminium Alloys			5. FUNDING NUMBERS Contract number F61708-93-C005

LASER INDUCED REACTION FOR PREBOND SURFACE PREPARATION OF ALUMINIUM ALLOYS

Stage 3 report (7-10/93)
Contract No. F61708-93-C005

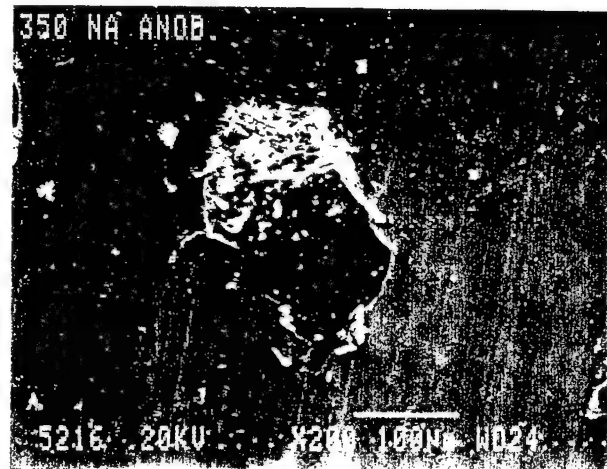
Fig. 3.8: SEM photographs of the surface failure morphology of SLS joints (table 3.3) with adhesive FM350NA, primer A187. a: without treatment. b: anodized adherends.

Figs. 3.8 -3.11 show the failure surface morphology of SLS adherends of joints bonded with FM350NA and primer A187. Comparison between the cohesive failure of the anodized adherends and the adhesive failure of the untreated adherends is shown in fig.3.8.

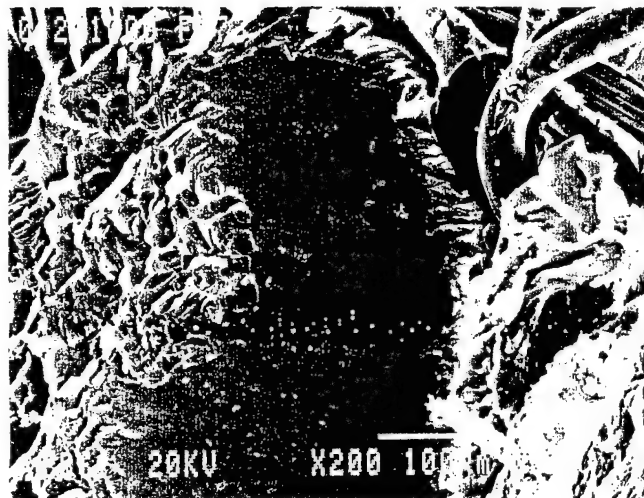
Fig. 3.12: SEM photographs of the surface failure morphology of SLS joints (table 3.4) with adhesive FM73, fresh primer BR127, laser energy $180\text{mj/p}\cdot\text{cm}^2$, 1000 pulses.

Experiments with a fresh BR127 primer and the adhesive FM73 (table 3.4) show that laser treated joints have shear strength similar to those with the primer A187 (329 Kg/cm²). Figs 3.12-3.13 show the cohesive failure mode of laser treated joints bonded with fresh BR127 and FM73. Experiments without a primer (table 3.5) and with an adhesive FM73 show shear strength of 321 Kg/cm². These results prove that the main effect of the surface treatment and improve adhesion strength arise from the laser irradiation while the primer has only a minor effect.
